Manhole Inspection Summary

Manhole # S67O__016MH

Insp Date: **2/7/08 1:29 PM**

Location Address: **6300 Boston St.**

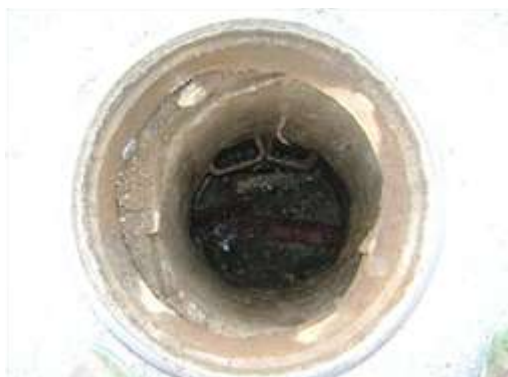
Defect 2

Offset: **3** (in.)

3 in. frame offset

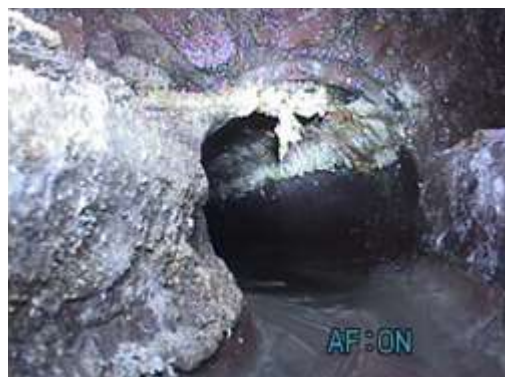
Defect 1

Condition: ☐ Sound ☐ Cracked ☐ Root Intrusion ☐ Deteriorated ☐ Leaks ☒ Debris

bench covered with grease

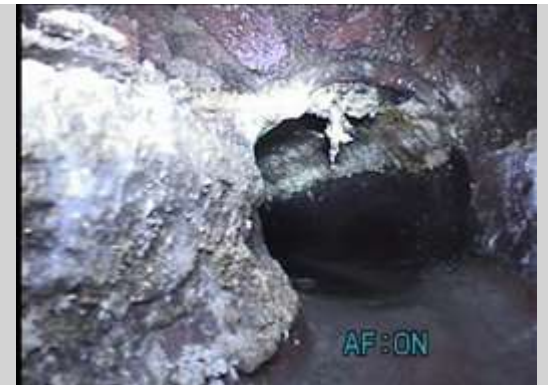
3 O'Clock Inflow

[dags] deposit attached grease 7 to the 2

Pipe Height: **8.4** (in.) Rod and Bar (Angled)
Pipe Material: **Clay** ☐ Pipe Lined
Invert Depth: **10.67** (ft.) Flow Characteristics: **Fast**
Deposits: ☐ None ☐ Mud ☐ Sludge ☐ Debris ☒ Grease
Silt Depth: **0.125** (in.) Deposits Extent: **Light**
Infiltration: **None** Pipe Seal Cond: **Sound**

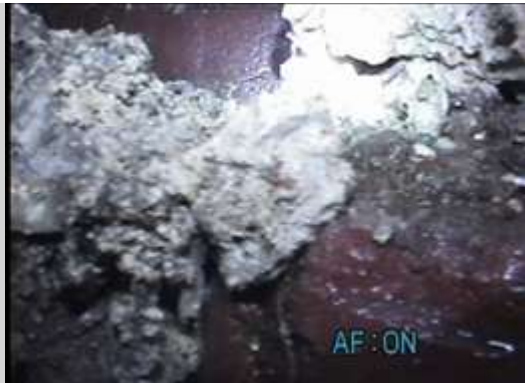
9 O'Clock Inflow

Incoming 9 impacted with grease

Deposits: ☐ None ☐ Mud ☐ Sludge ☒ **Debris** ☐ Grease

Silt Depth: **6** (in.) Deposits Extent: **Heavy**
